416 SERVICE INFORMATION

Type(s): 6121, 6126, 6700, 6701, 6702, 6703, 6704, 6705

SUBJECT: CHECK PAWL, SPRING, STUD AND TAB KEYLEVER — REDESIGNED

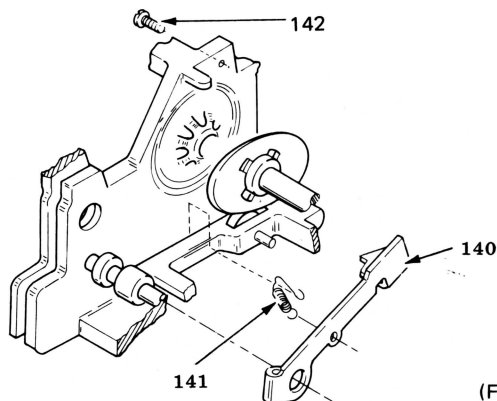
(Figure 1)

The cycle clutch check pawl, stud and spring has been designed to improve cycle shaft cam stop location (Figure 1).

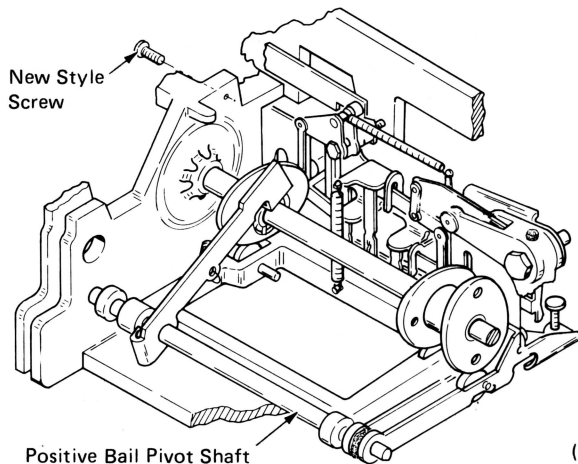
(Figure 2)

The new pawl (23-140) is now mounted on the positive bail pivot shaft (23-118). The screw (23-142) replaces the studs (23-417, 423). The studs (23-417, 423) will remain available for replacement on old level machines (Figure 2).

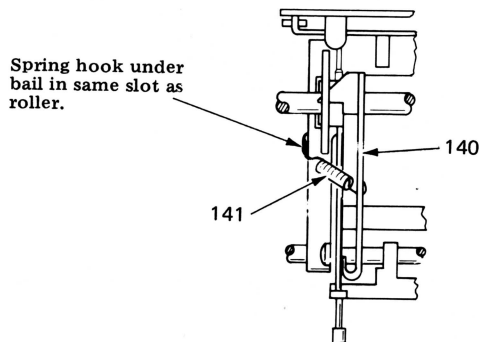
(Figure 3)

The pawl is spring loaded to the left by spring (23-141), and is connected to the positive bail as shown in Figure 3.

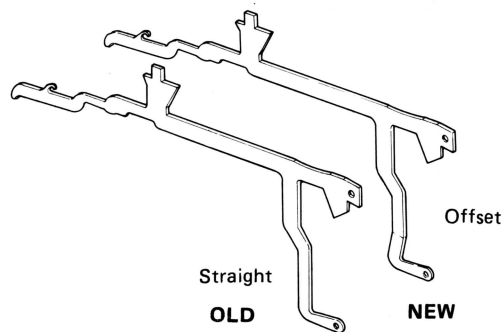
(Figure 4)

The tab keylever (18-28, 19-43) has been redesigned (Figure 4), to ensure there is no interference between the check pawl (23-140) and tab keylever. The new redesigned tab keylever will work on all level machines. The old level keylever will be obsolete. Scrap all old level keylevers and reorder new style.

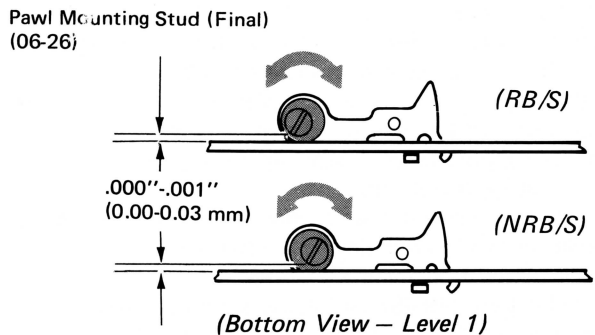
Frame 119 of APM 241-5939-3 is incorrect. On NRB/S machines, the eccentric screwhead should be to the left and on RB/S machines, the eccentric screwhead should be to the right. This correction is shown in Figure 1. Mark this change in your APM.

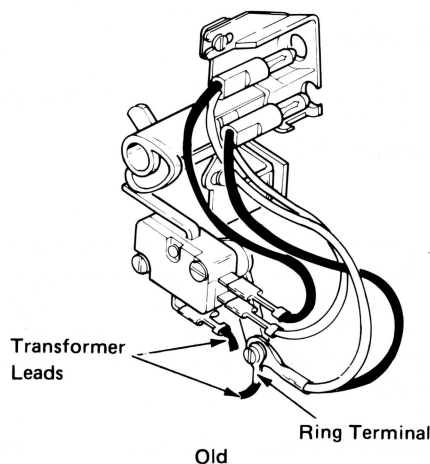
The method of connecting the secondary wiring at the margin light switch plate (10-109) has also been changed. Figure 1 shows the old method of connection and Figure 2 shows the new. The switch plate will be redesigned as illustrated in Figure 3. The old plate will be used until stock is depleted but the wires will be connected as illustrated in Figure 2.

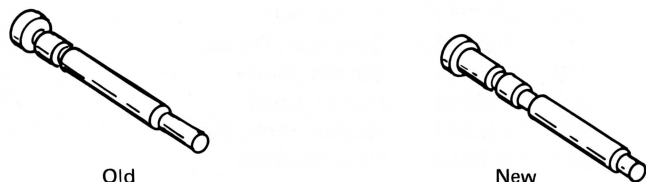
Figure 1

Selective ribbon machines are now manufactured with the same ribbon feed cam follower, FTB (15-010) as is used in Electronic Typewriter. A new pin (15-019) is required to mount the follower. (Figure 1 illustrates the old and new pin).

The former level follower is no longer available. If replacement is required, order both the new follower and pin. Old level pins remain available.

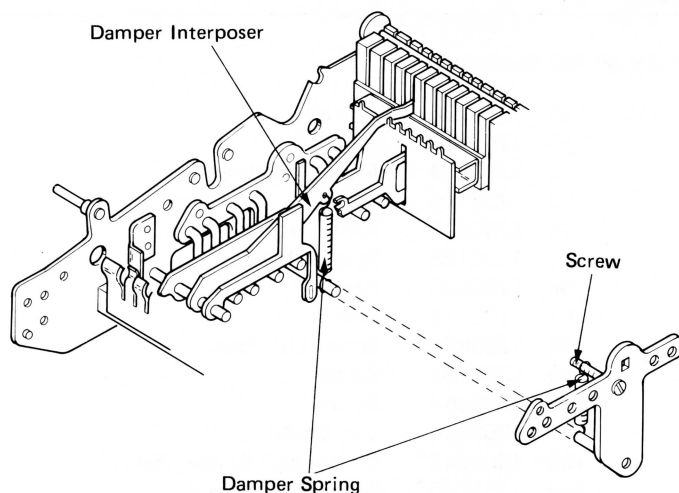
Figure 1

The cycle clutch bail leaf spring (21-240) has been replaced with coil springs on both sides of the key board. This change was made in order to maintain a more reliable adjustment of the cycle clutch latch pawl to keeper on the assembly lines. It will also allow the touch to be distributed more evenly across the keyboard.

The LH spring (21-210) is connected to an interposer (21-113) that has been added to the LH side of the keyboard (Figure 1). The right and left damper springs can be installed in keyboards in the field by ordering the interposer, screw, and springs. On the RH side replace the center screw in the plate with the longer screw that was ordered and attach the spring. The center leaf spring will remain available.

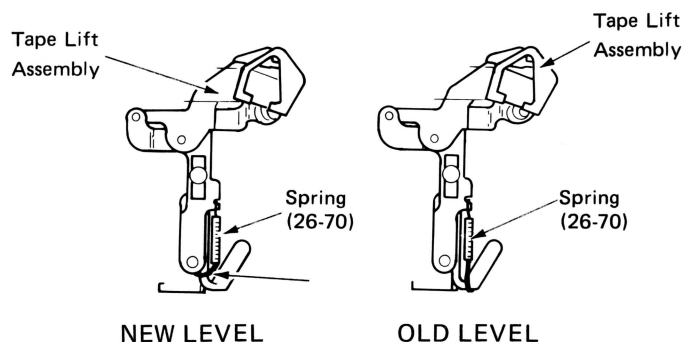
Figure 1

The correction lift guide restore spring (26-70) has been redesigned to prevent the bottom loop from contacting the D.I. cable or dust shield. The new shorter spring hooks in a corner of the lift bracket as shown in Figure 1.

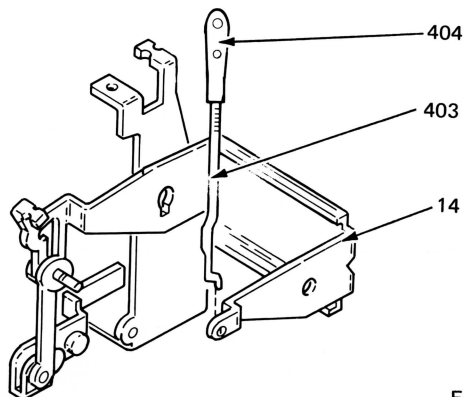
Figure 1

The lower end of the index link (20-403) has been changed to improve reliability. The new link utilizes an offset in place of the permanently mounted clevis. The new link may be installed by first removing the trigger restore spring (07-41). Install the offset end of the link as shown in figure 1. Then attach the clevis to the link from the top of the machine.

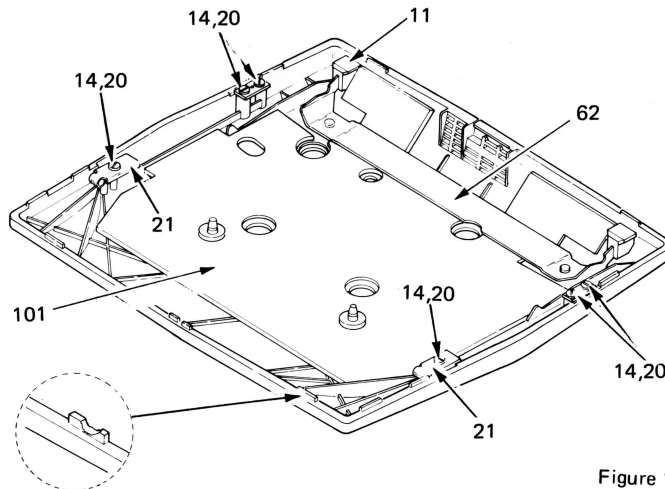
Figure 1

When converting from a metal bottom cover to a plastic bottom cover, check for a possible interference between the bottom cover and the center cover. A limited number of center covers (30-156) were manufactured with a rib that may contact the front guide lug on the plastic bottom cover (Fig 1). This interference can be eliminated by filing enough material from the front bottom cover plastic guide lugs to allow proper assembly.

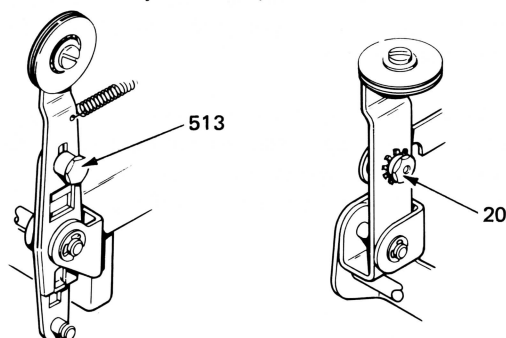
Figure 1

Manufacturing has redesigned the rotate arm screw (23-513) and the tilt arm nut (23-20) for the purpose of using an automated selection adjustment system (Fig 1).

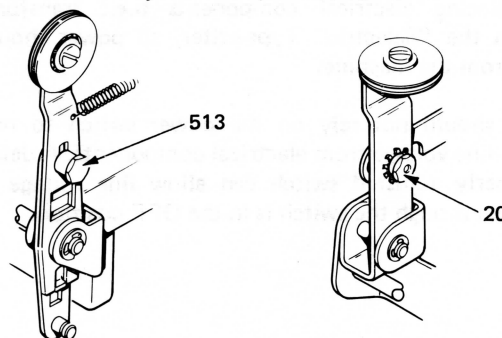
Figure 1

Manufacturing has redesigned the rotate arm screw (23-513) and the tilt arm nut (23-20) for the purpose of using an automated selection adjustment system (Fig 1).

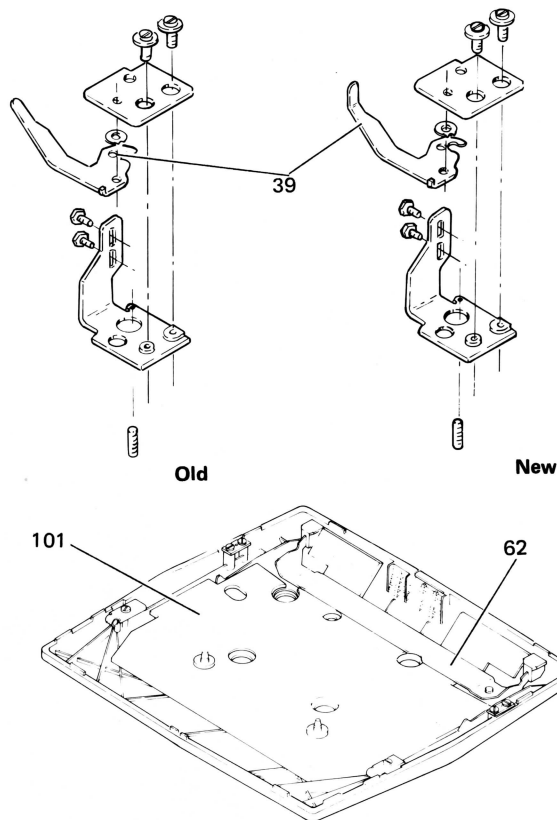
Figure 1

The IBM Personal Typewriter is now being manufactured with a plastic bottom cover. The new plastic bottom cover is interchangeable with the previous level metal bottom cover.

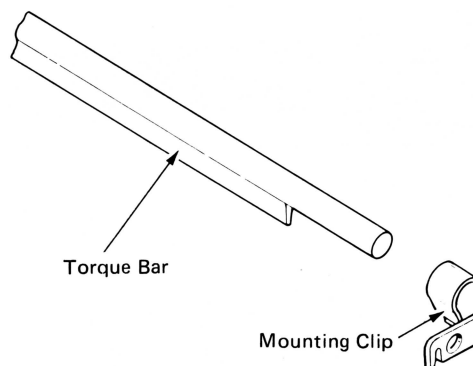
Figure 1

The Pre-Floating torque bar P/N 1206100 has been replaced by a B/M. The new B/M includes a Mag Card torque bar and two clips. When installing the B/M, remove the Mag Card torque bar spring anchor and install the new link mounting clip (Fig 1). A clip is included which should be used to control torque bar end play.

NOTE: After removing the Mag Card torque bar spring anchor, use a file to remove sharp edges.

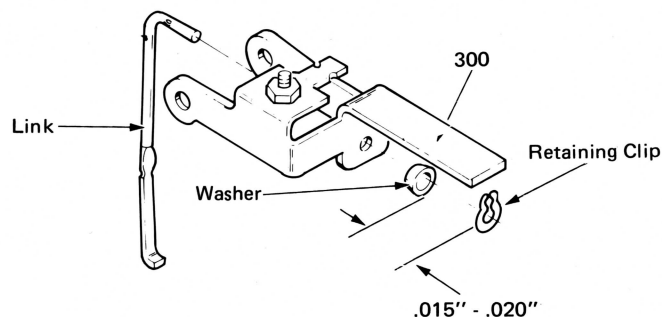
Figure 1

The Spacebar Latch Assembly (17-300) is now assembled with a replaceable latch link for use in the Personal typewriter. Should replacement of the latch link become necessary, a B/M is available which contains the link, a washer and a retaining clip.

The new latch link B/M can be installed on non-rotary backspace machines (7X1, 8X1) without removing the latch assembly.

NOTE: Maintain a .015" - .20" clearance between the washer and retaining clip.

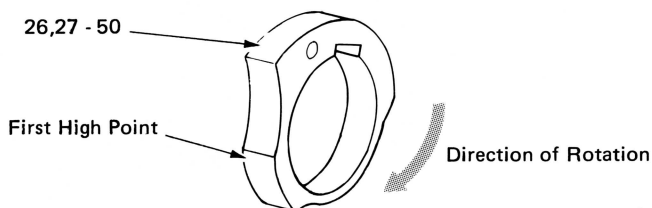
Figure 1

Some machines were manufactured with a defective correction tape feed cam (26, 17-50) which is slightly undersized on the first high point. This condition can be observed by slowly hand cycling the correction mechanism while checking the amount of correction tape feed. The tape should feed one-third before print and two-thirds after print. Machines failing to pull enough tape during the initial feed operation will have random correction failures.

Defective correction feed cams can be replaced without removing the ribbon plate assembly.

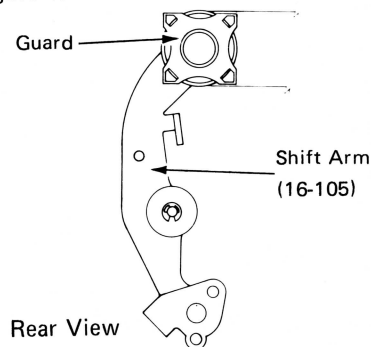
Figure 1

To reduce repeated rotate tape replacement caused by the tape becoming disengaged from the shift arm pulley, the Mag Card velocity tape guard (25-34; P/N 1457036) may be installed. Prior to installing the guard, ensure that a machine malfunction is not causing the tape problem. Install the guard as shown in figure 1.

NOTE: Due to a tolerance build-up of the related parts (shift pulley, rotate tape and velocity guard), a binding condition may occur on some machines. Reducing the length of the velocity guard tips by sanding, filing, etc., will reduce the binding condition.

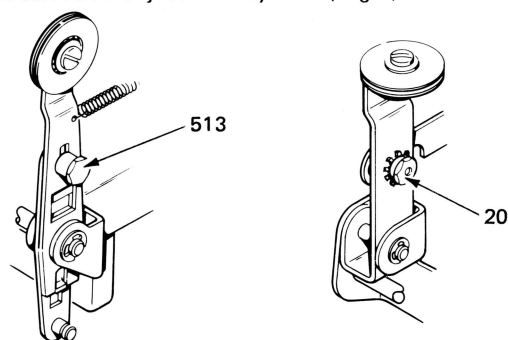
Figure 1

Manufacturing has redesigned the rotate arm screw (23-513) and the tilt arm nut (23-20) for the purpose of using an automated selection adjustment system (Fig 1).
